Manhole Inspection Summary

Manhole # S19E__008MH

Insp Date: **10/12/07 11:50 AM**

Location Address: **2101 MULBERRY ST**

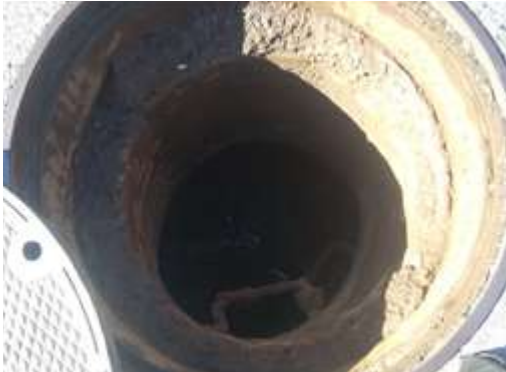
frame too big

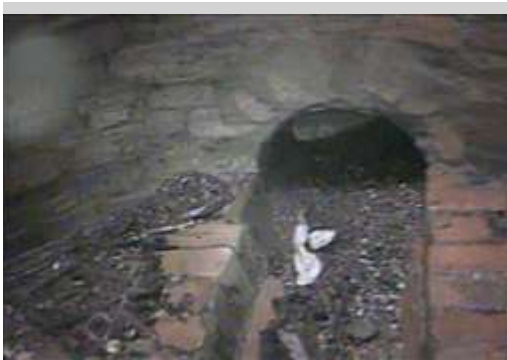
Defect 3

Condition: ☐ Sound ☐ Cracked ☐ Root Intrusion ☐ Deteriorated ☐ Leaks ☒ **Debris**

CHANNEL DEBRIS

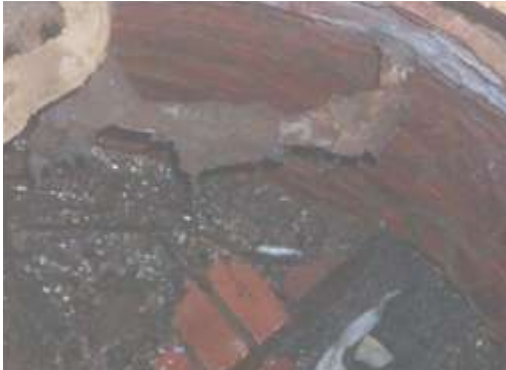
Defect 2

☒ **Evidence Of Surcharge** Depth: **5** (ft.) ☐ Active Surcharge Present

SURCHARGE EVIDENCE ON STEPS

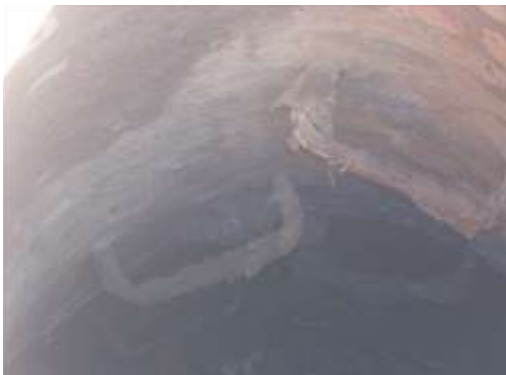
Defect 1

Count: **5** Missing: **0** ☒ **Corroded**

CORRODED STEPS

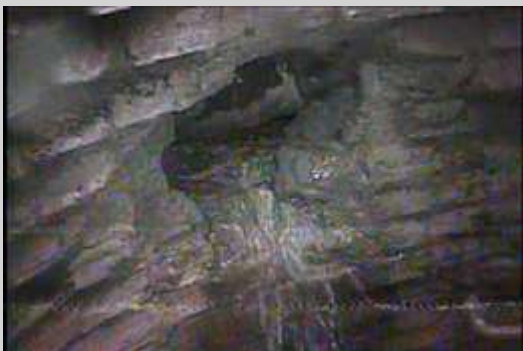
3 O'Clock Inflow

Pipe Height: **8.4** (in.) Rod and Bar (Angled)
Pipe Material: **Clay** ☐ Pipe Lined
Invert Depth: **5.39** (ft.) Flow Characteristics: **Slow**
Deposits: ☐ None ☐ Mud ☐ Sludge ☒ **Debris** ☐ Grease
Silt Depth: **2** (in.) Deposits Extent: **Medium**
Infiltration: **None** Pipe Seal Cond: **Sound**

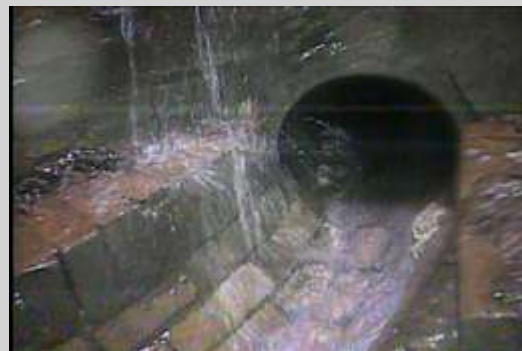
Drop In @ 3 O'Clock

Drop: **Outside** Rod and Bar
Angled: **Yes** Reading: **7.21** (ft.)
Inv Depth: **8.21** (ft.)
Drop Condition: **Partly Clogged**
